ACEQUIA DE LA PUEBLA

2013 ANNUAL MEETING

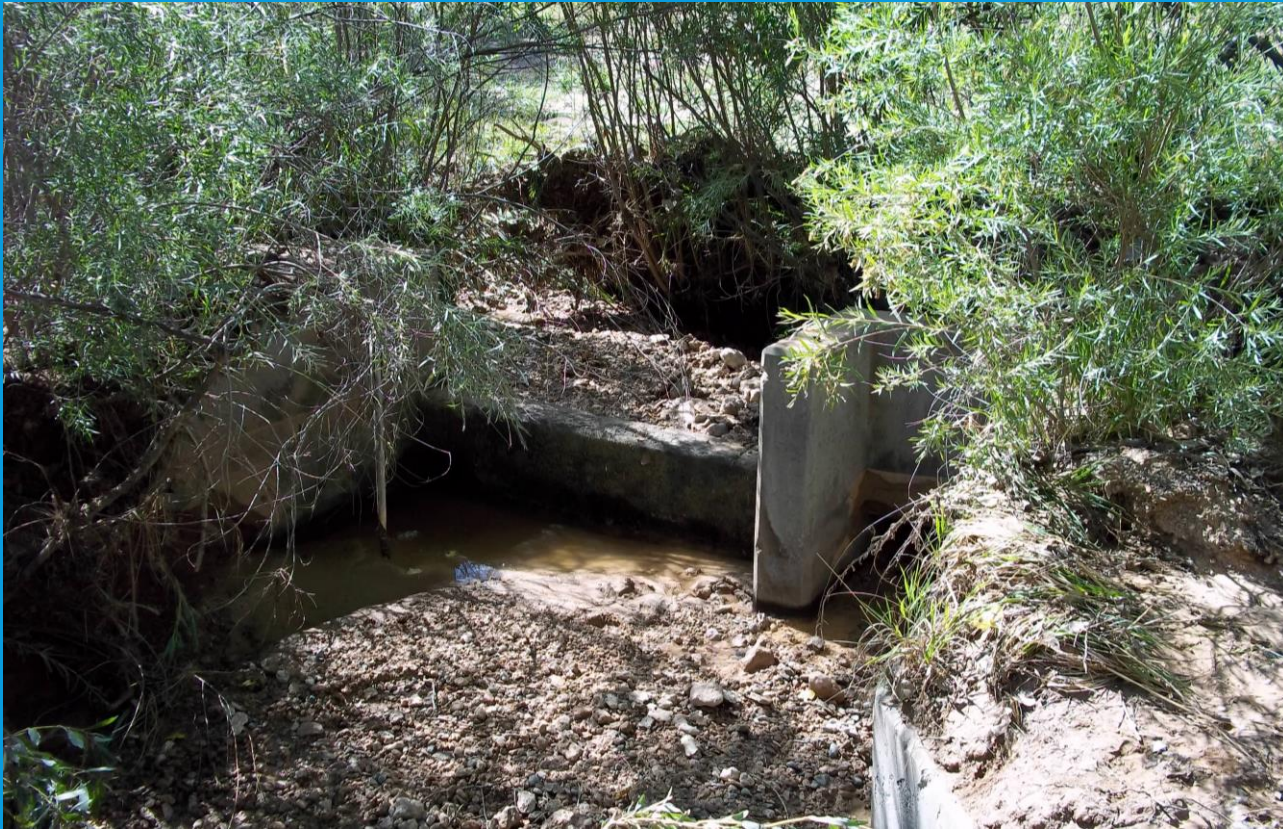
THE ACEQUIA'S FIRST DESAGUE

This is the acequia's first, and probably the most crucial, desague. In the 2011 flood, the desague was filled with mud, rock and debris. This desague is a few hundred feet from the presa (diversion) on the Santa Cruz River. The river brings large amounts of sand into the acequia during normal operation, so functioning desagues are critical.

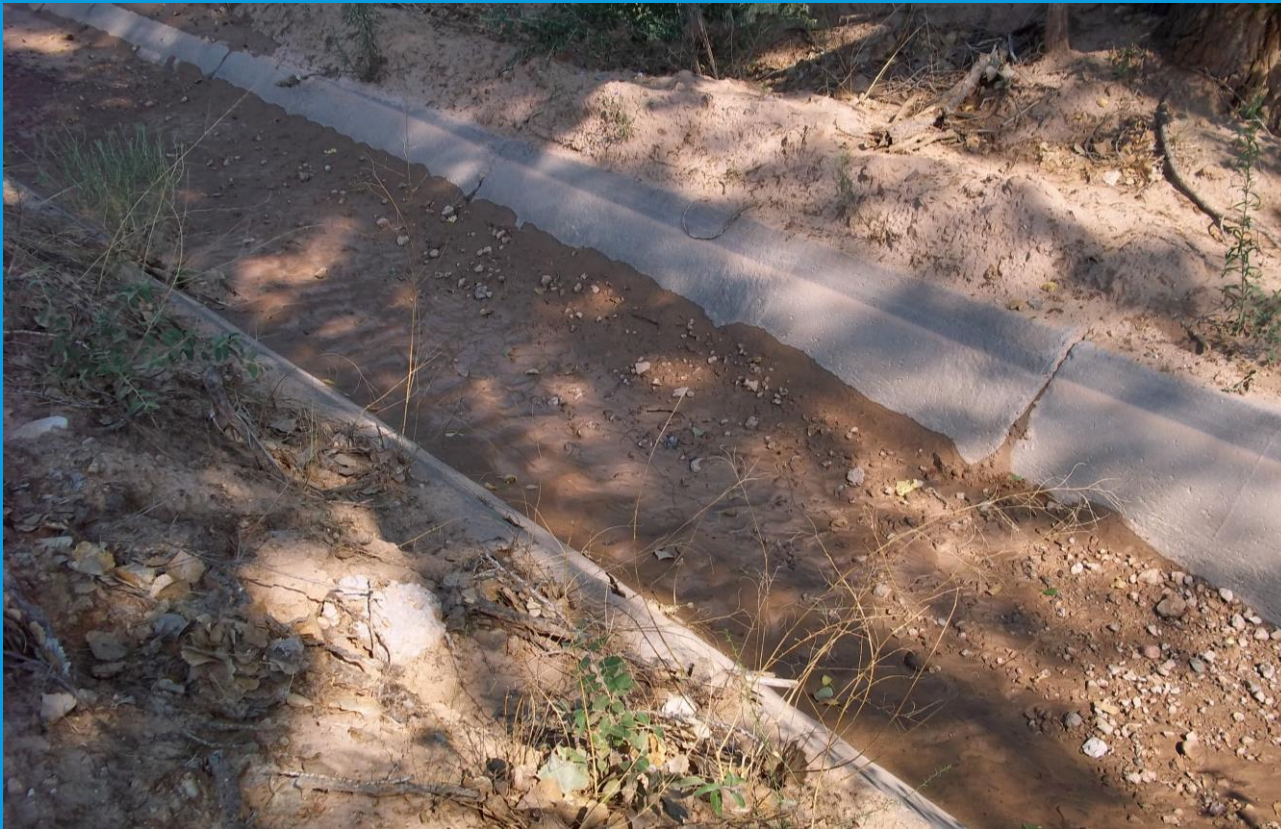
ACEQUIA MADRE PARTIALLY FILLED WITH SEDIMENT FROM THE 2011 FLOOD

This is the Acequia Madre which is much larger than the Llano or the Sitio. In this area, the acequia was filled-in with sediment for over a mile, possibly two miles.

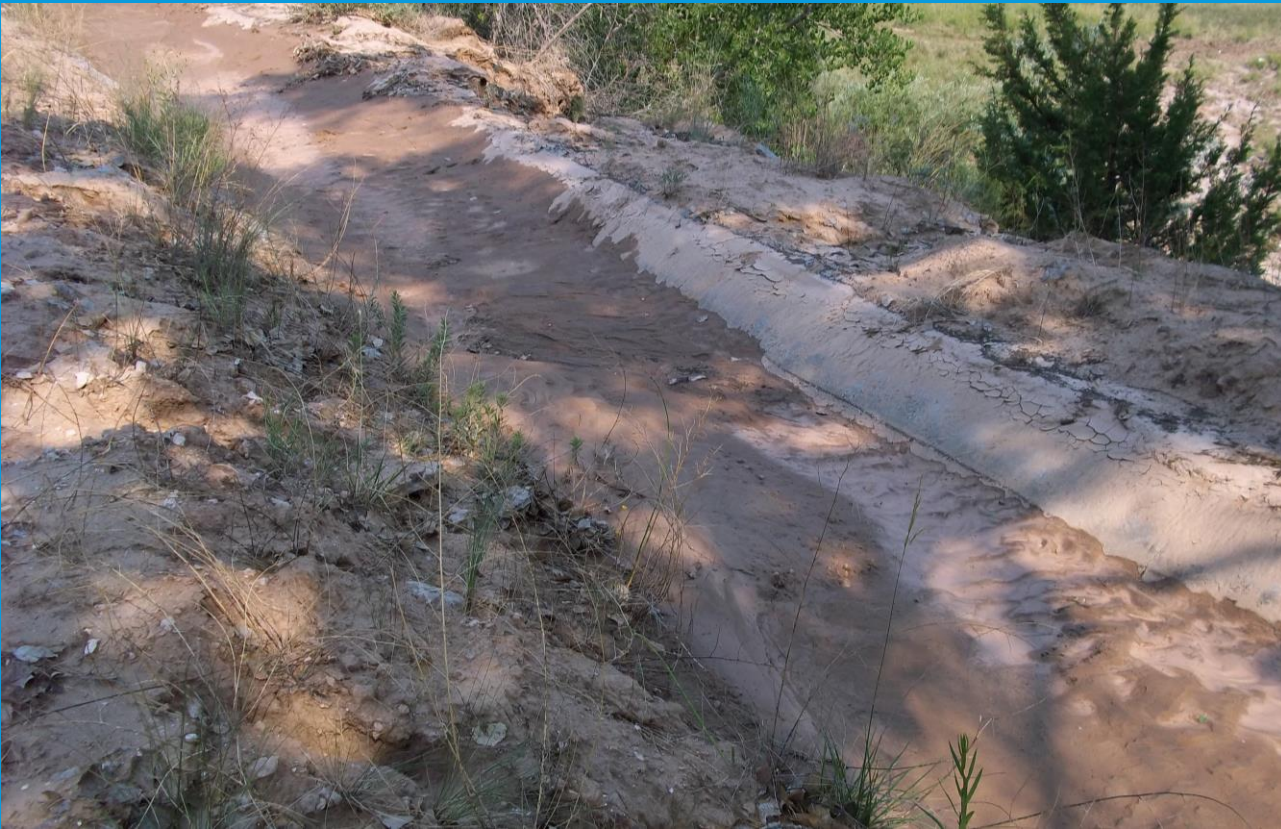
ACEQUIA FILLED-IN WITH SEDIMENT IN 2011

Note the upper left corner of the photo where the acequia is completely covered. The acequia bank on the far side is eroded from the water and mud which spilled over the acequia bank. The bank was completely washed away and the acequia cement liner was hanging in mid-air. Luckily, the cement liner did not collapse.

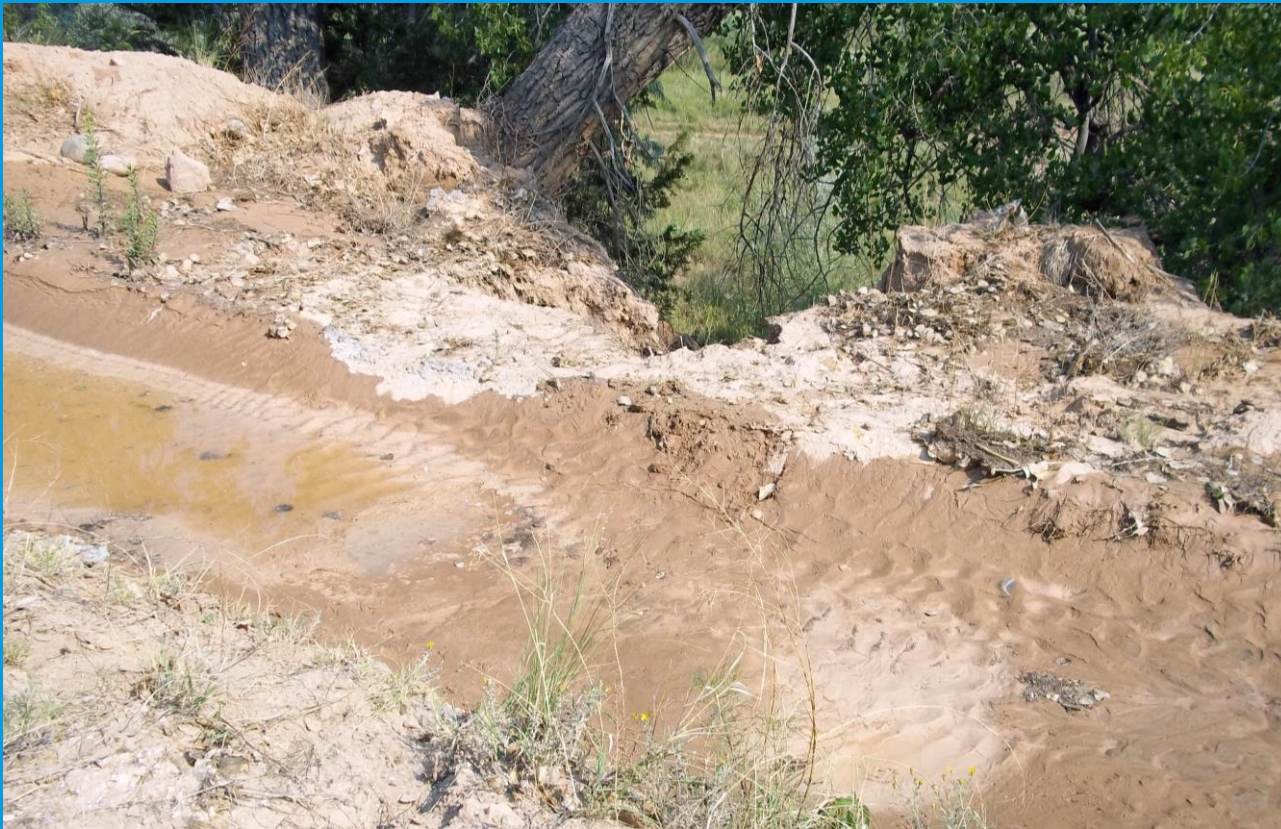
ACEQUIA FILLED-IN WITH SEDIMENT AND BANK ERODED FROM FLOODING

The acequia is in the foreground. It is completely filled-in with mud. The acequia bank is eroded from water and mud spilling over it's side.

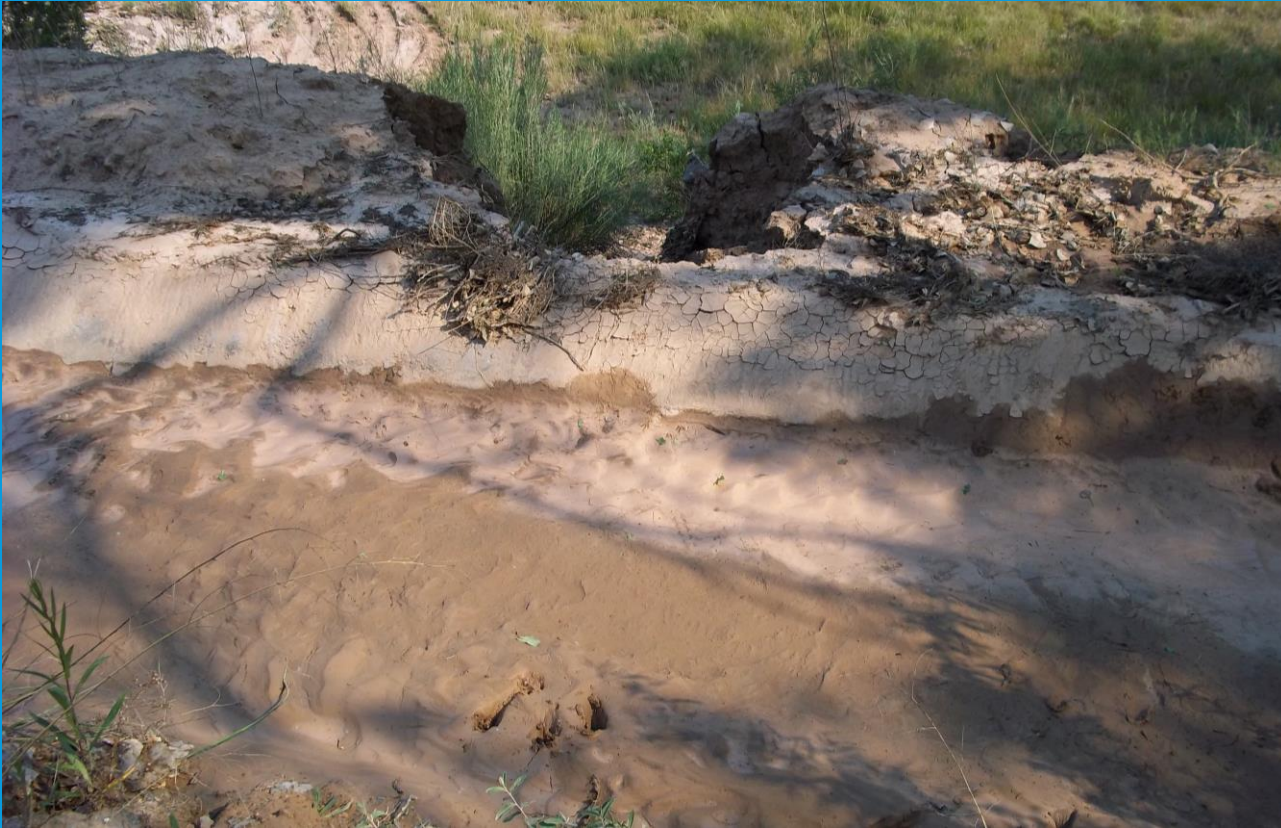
ERODED ACEQUIA BANK FROM 2011 FLOOD

The acequia's bank has eroded from the intense flow of mud and water. Note the steep drop on the eroded side of the bank. This drop-off is approximately 20 feet. With the bank eroded, the acequia was literally suspended in air. Thankfully, the cement liner held; if it would have broken, we would have had a major problem.

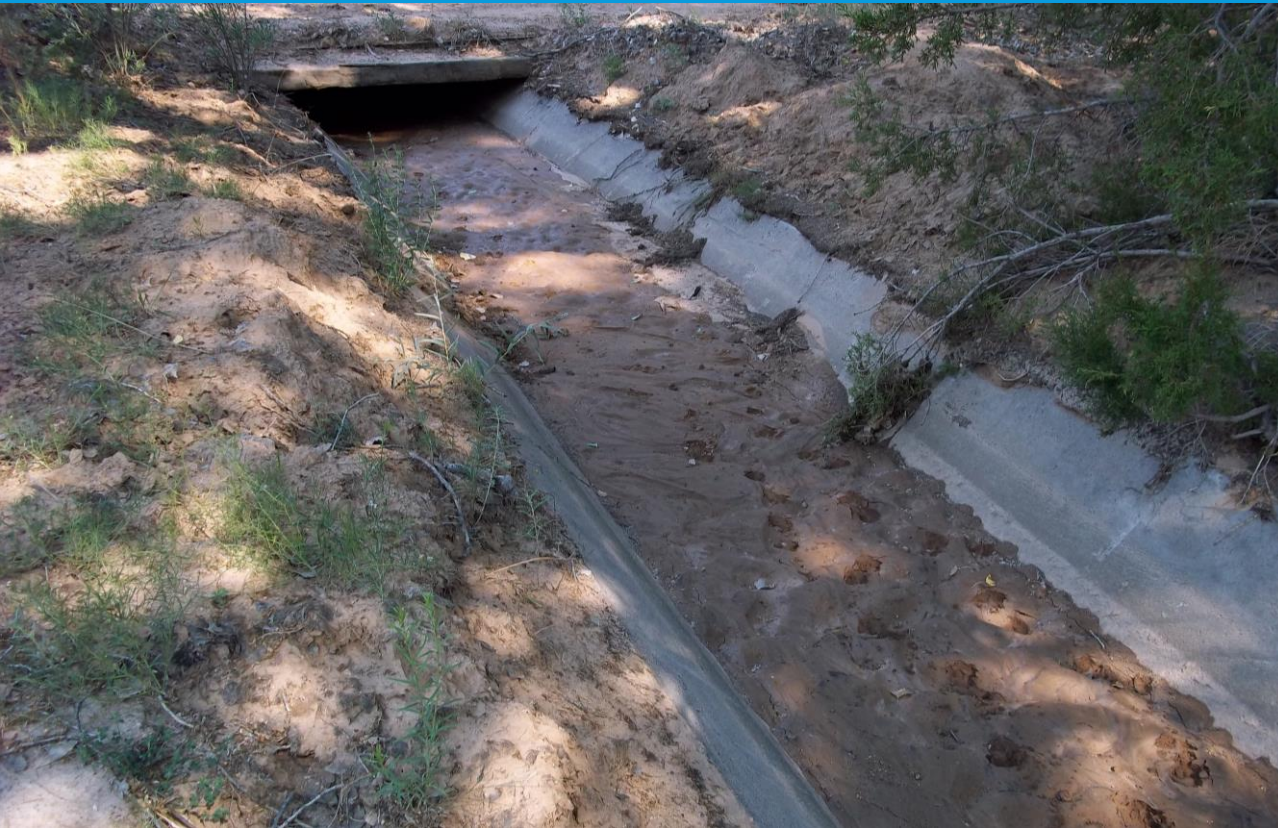
FILLED-IN ACEQUIA AND BRIDGE RESTING ON CEMENT LINER

This section of the acequia is partially filled-in with sediment. The bridge seen at the top of the slide is resting on the cement liner.

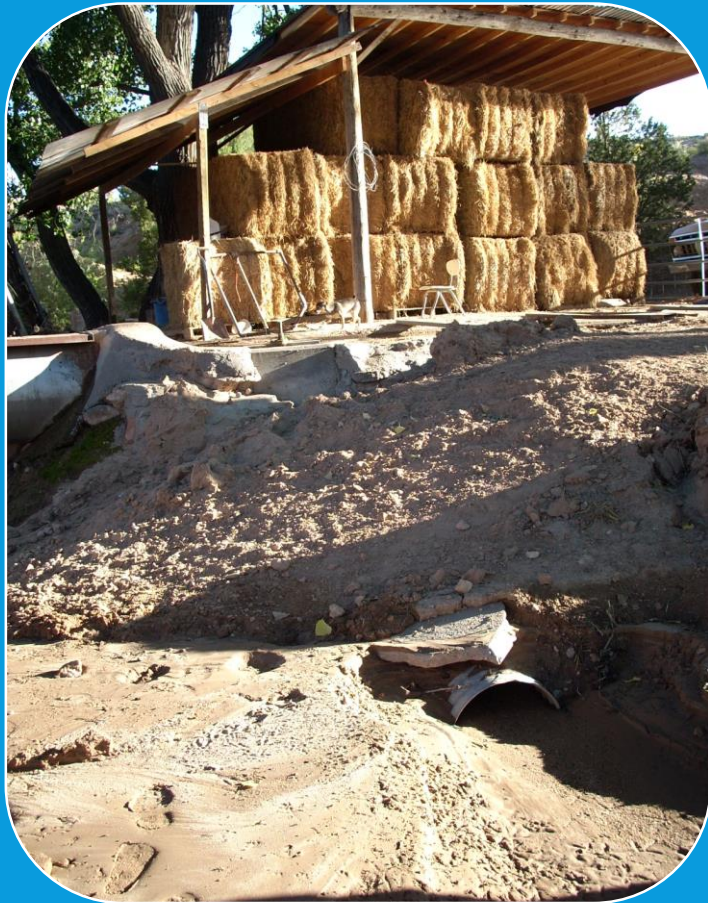
DESAGUE BURIED IN SEDIMENT

This is the acequia's second desague. The cano is buried in sediment due to a blocked arroyo. As a result, the desague was inoperable. Functioning desagues are critical to keeping the acequia clean.

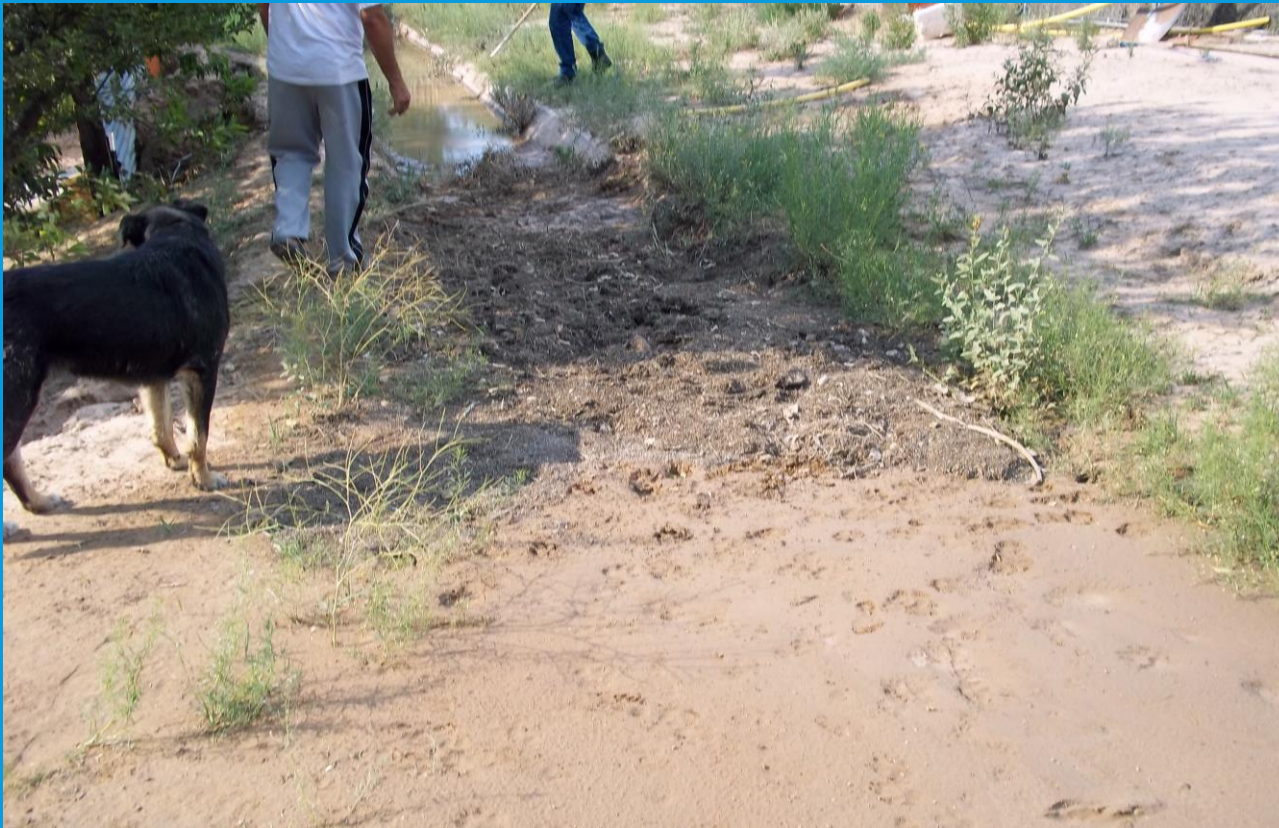
THERE'S AN ACEQUIA UNDER THAT MUD!

The acequia can be seen at the top of the slide, between the two men. The acequia is also in the foreground, completely covered by sediment. At this location, an arroyo is responsible for the filling in the acequia.

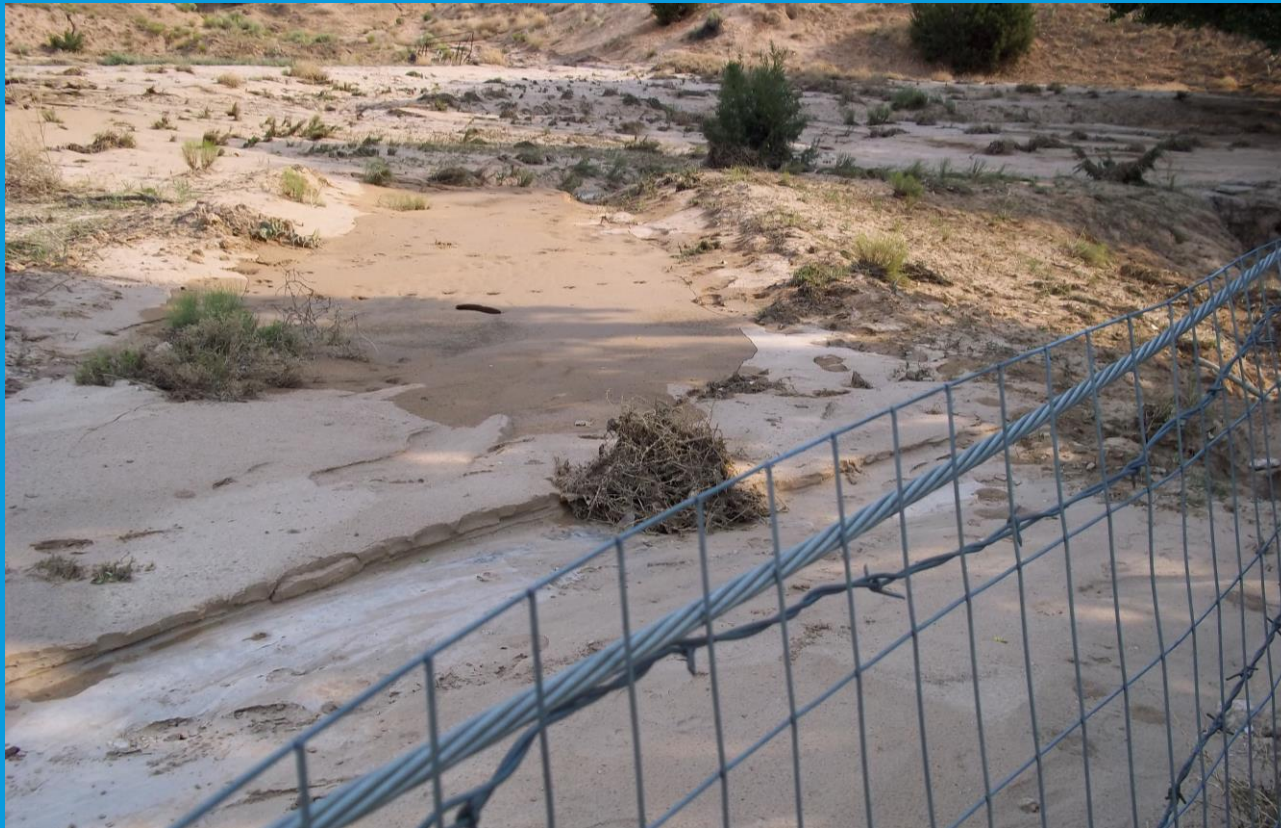
WHERE'S THE ACEQUIA?

This is the same location as the previous slide. The acequia is right there, in the middle of the slide, but you wouldn't know it.

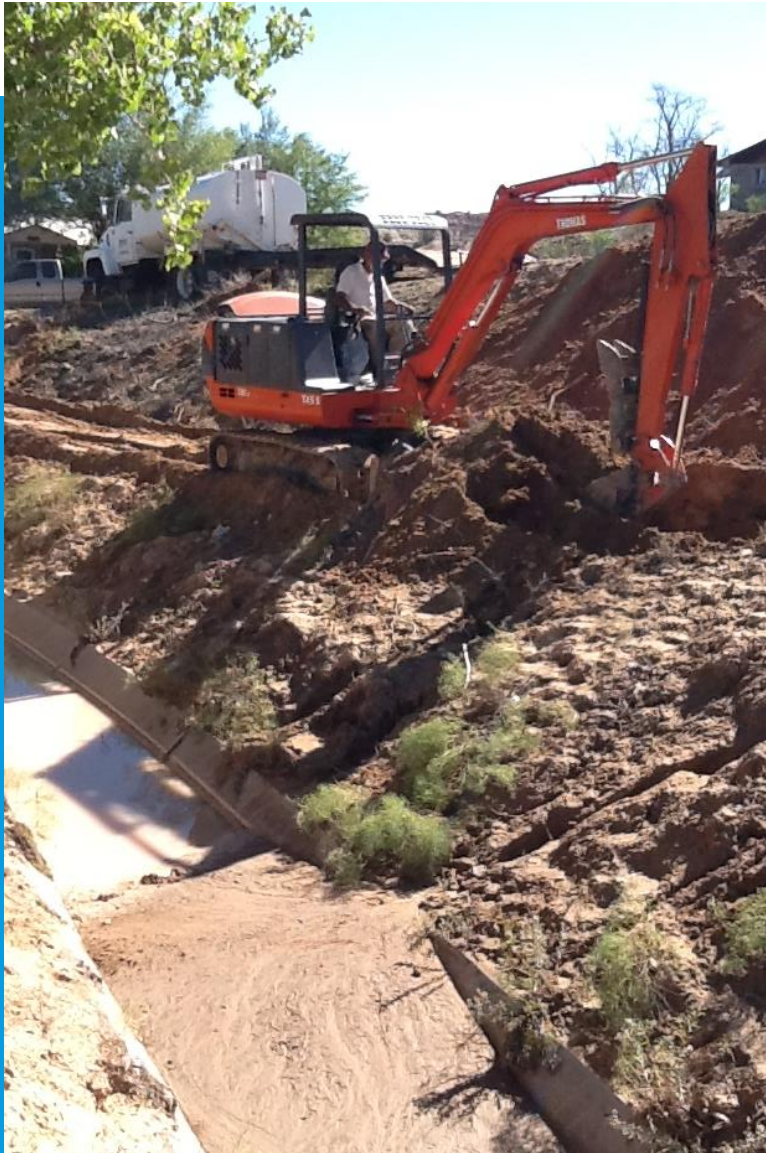
TRACK HOE CLEANING ACEQUIA AFTER 2013 FLOODING

A Track Hoe was hired to clean many areas of the acequia after the 2013 flood. Due to very dry conditions this summer, many native plants and grasses were absent in the dry lands of the BLM. The result was an immense amount of sediment was contained in the flood waters from the arroyos on the BLM.

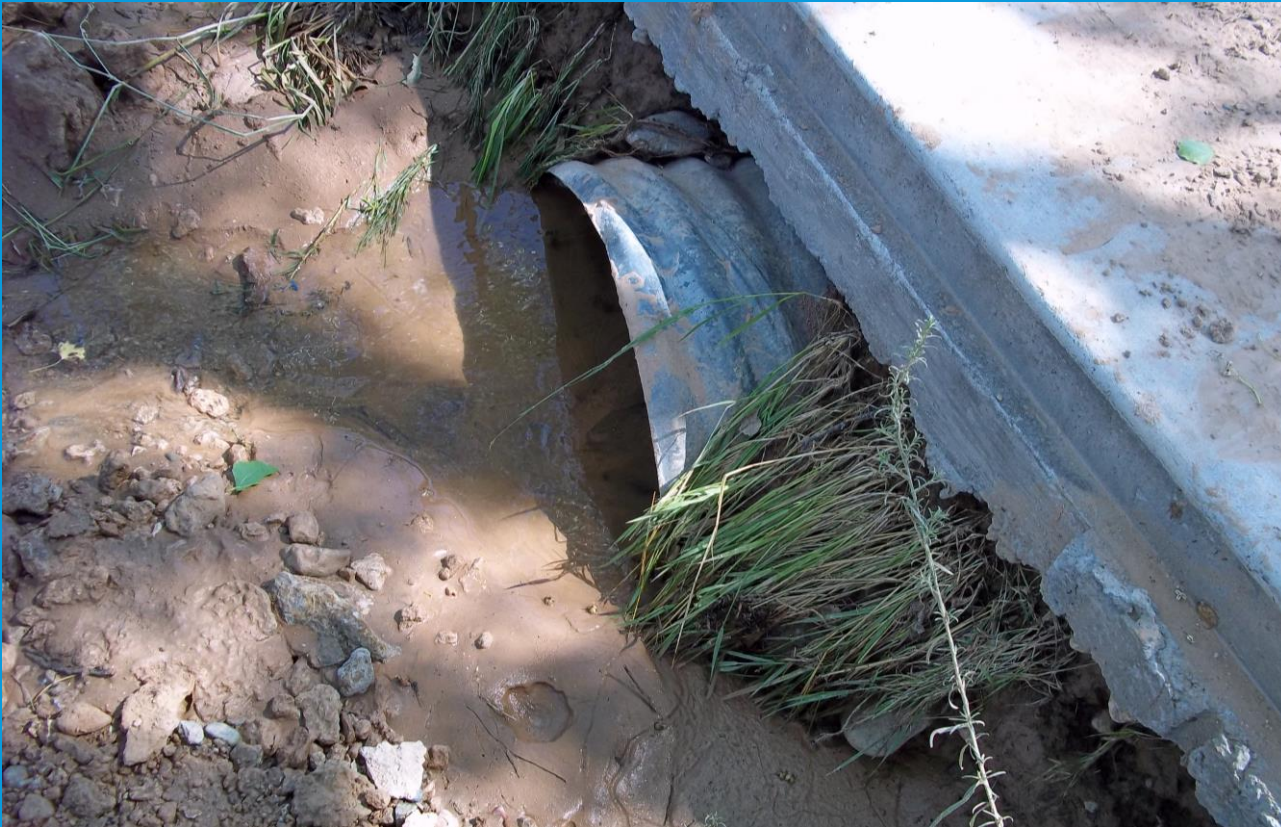
ACEQUIA FLOWS UNDER A CEMENT BRIDGE

The acequia is filled with sediment from the 2011 flood. The acequia is a dirt ditch in this location. Two brothers cleaned this cano which was packed with rock and mud. It took several hours to complete the job.

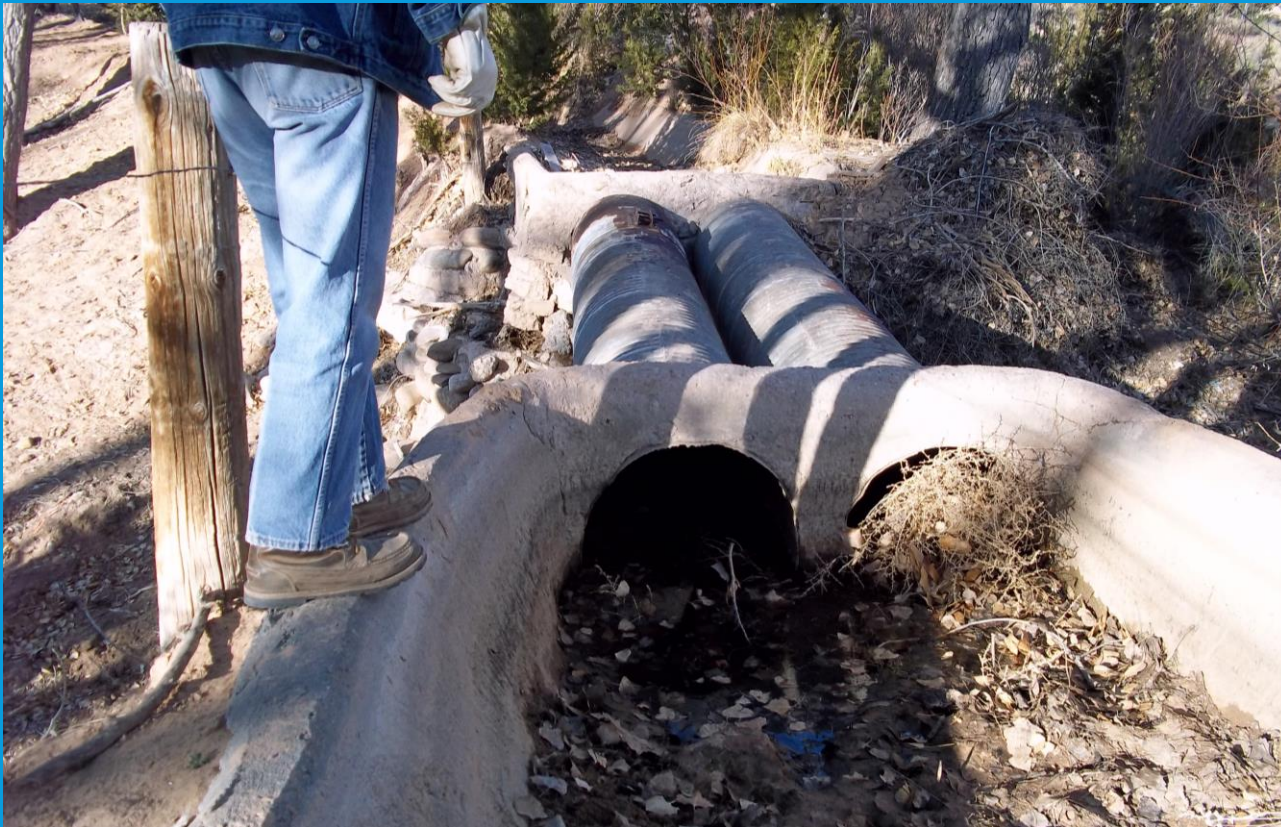
DOUBLE CANOS FILLED WITH SEDIMENT

This is the area called the 'Double Canos'. Here the acequia was filled with mud and debris from the 2011 flood. We discovered a desague at this location which had been purposely blocked. Once it was cleaned out, the mayordomo was able to use it to keep the acequia clean.

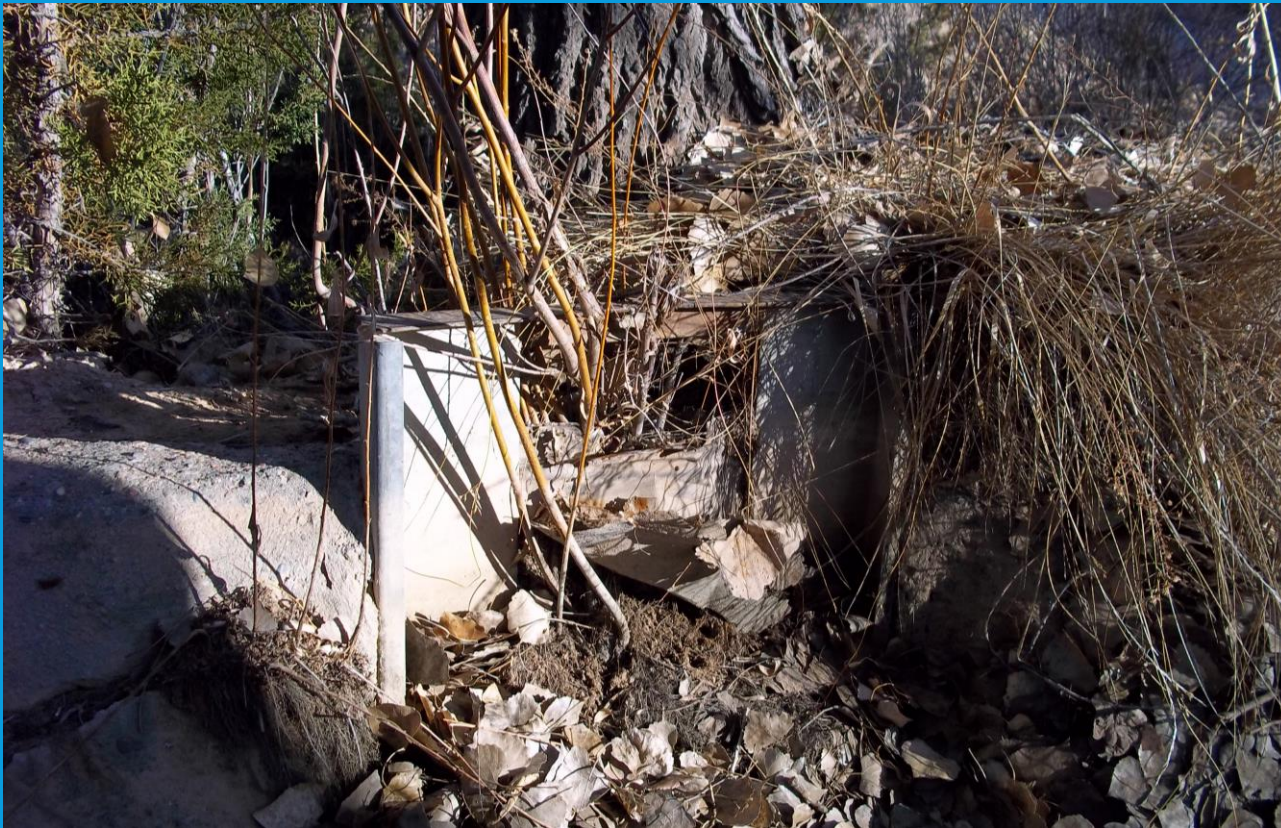
DESAGUE BLOCKED FOR MANY YEARS

This desague was blocked for many years. After cleaning the desague, a resident in the area blocked it again. The Commissioners met with the neighbors and were able to stop the destructive activity.

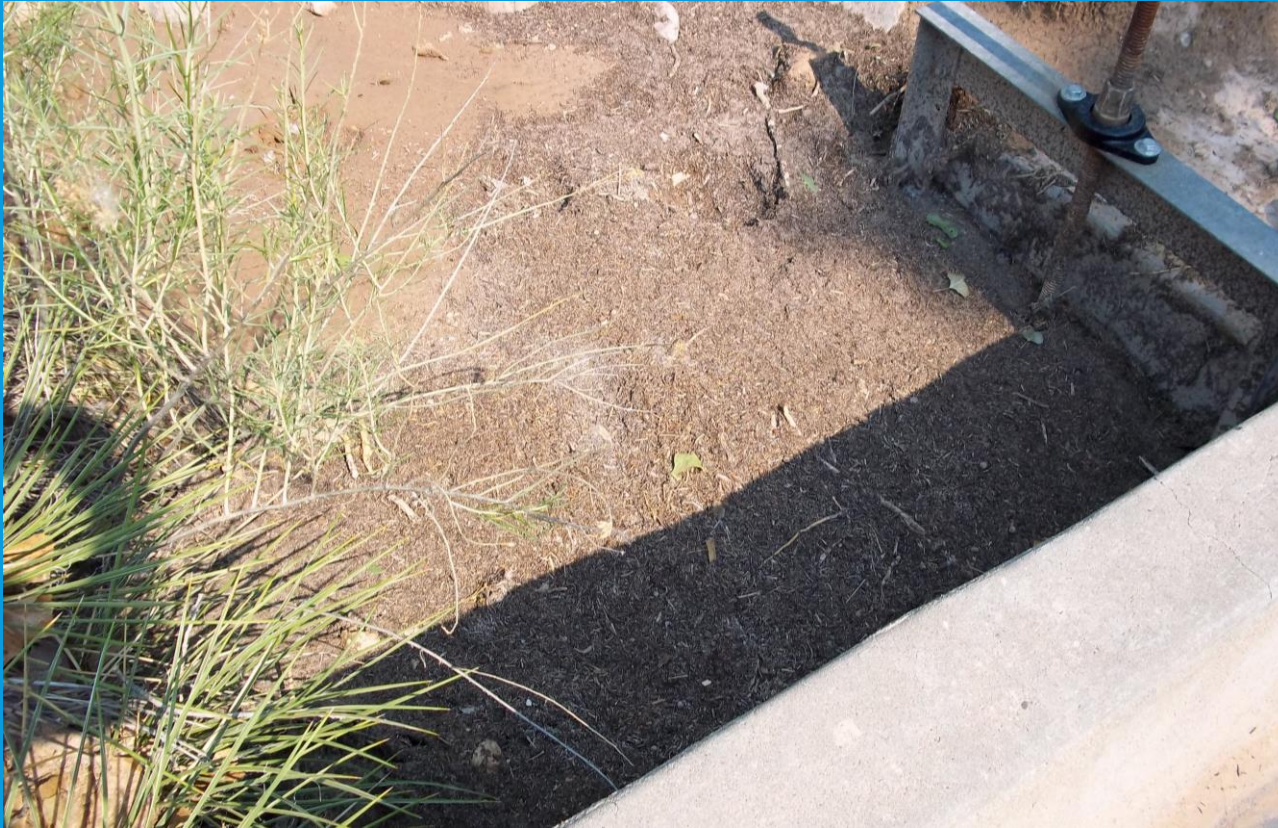
DESAGUE FILLED-IN WITH SEDIMENT

This desague is filled to the top with mud from the 2011 flood. Santa Fe County helped clean the acequia and the desagues and they also reconstructed the eroded acequia bank. SFC worked for several weeks on the acequia. One parciante rented a track hoe, at his own expense, and cleaned the parts of the acequia. Much of the cleaning was done by hand.

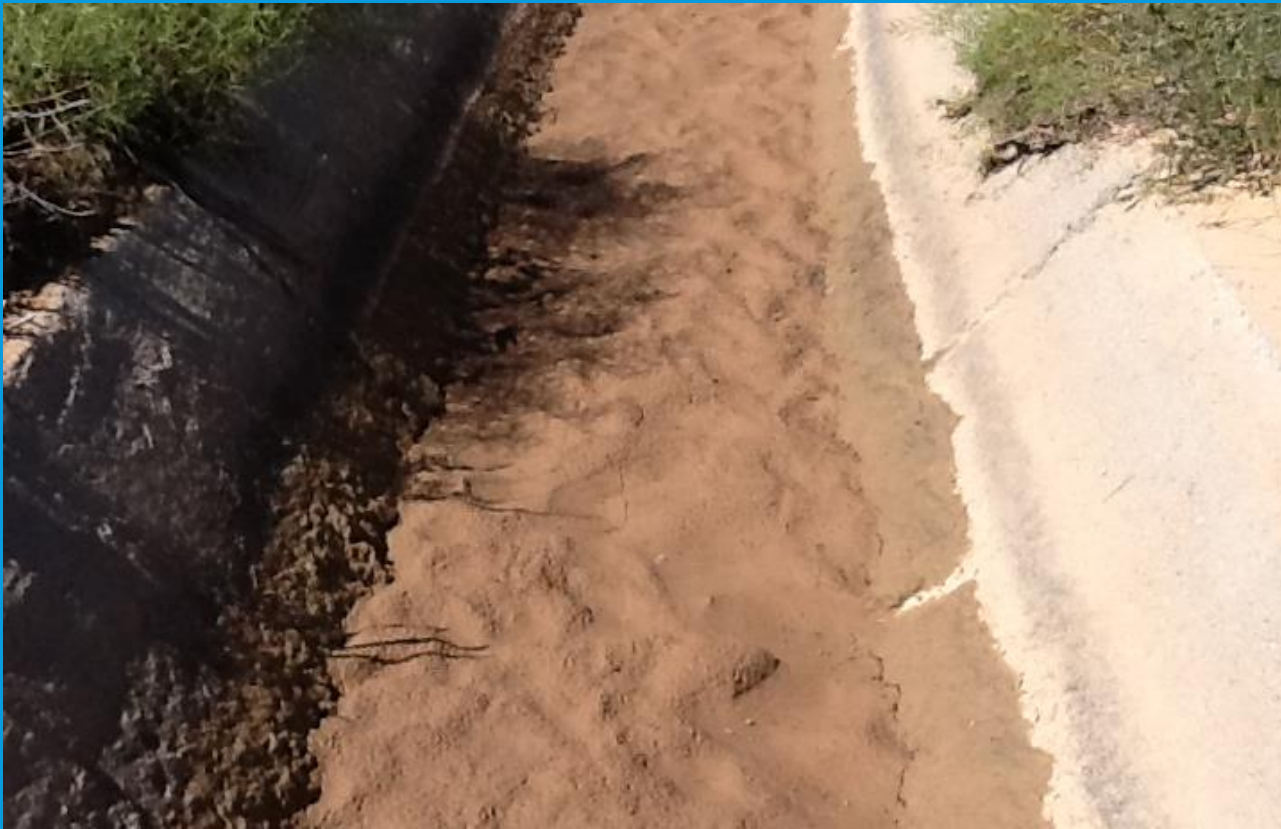
SEDIMENT IN THE ACEQUIA MADRE

This sediment in the acequia is a result of the 2013 flood. Art employed the track hoe to remove as much of the sediment as possible from the acequia.

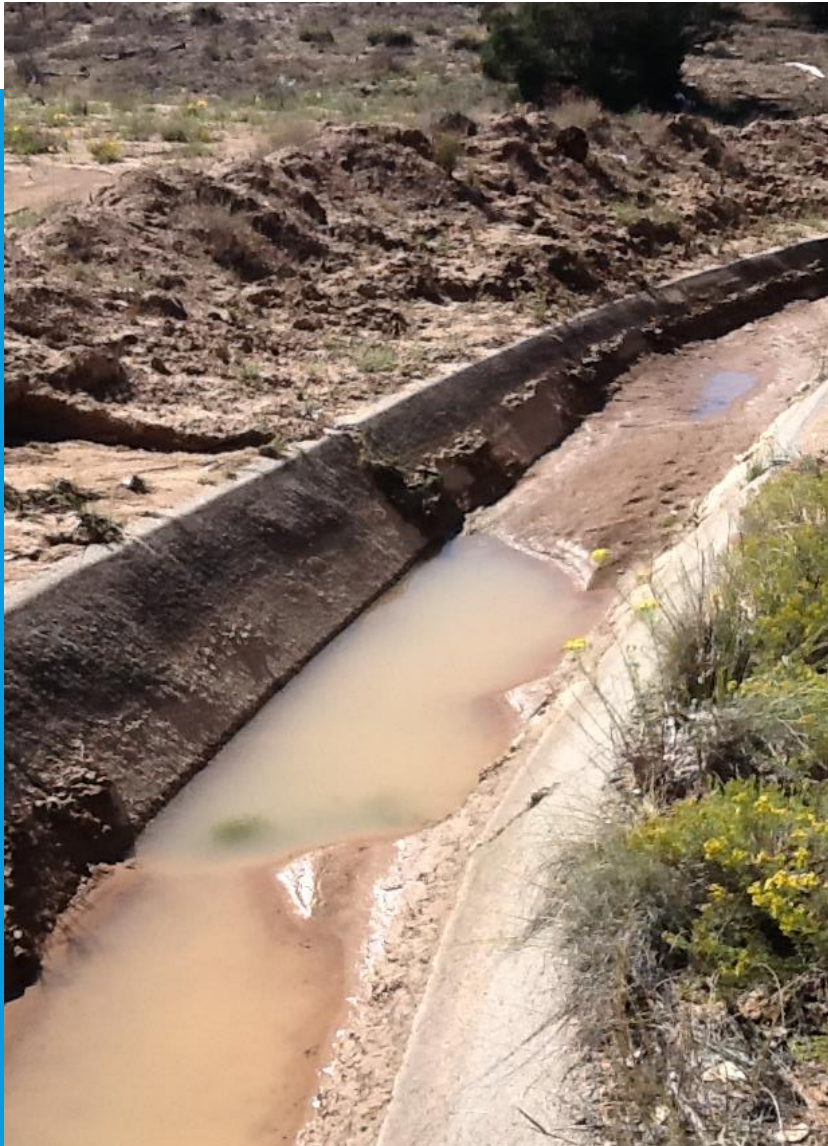
SEDIMENT FROM THE 2013 FLOOD

Along with the sediment in the acequia from the 2013 flood, notice the piles of dirt on the acequia bank. Dirt piling up along the acequia bank is becoming an ever increasing problem. Our by-laws state that our members are responsible for keeping their acequia sections free of trash and other obstructions (Article 6, Section 1).

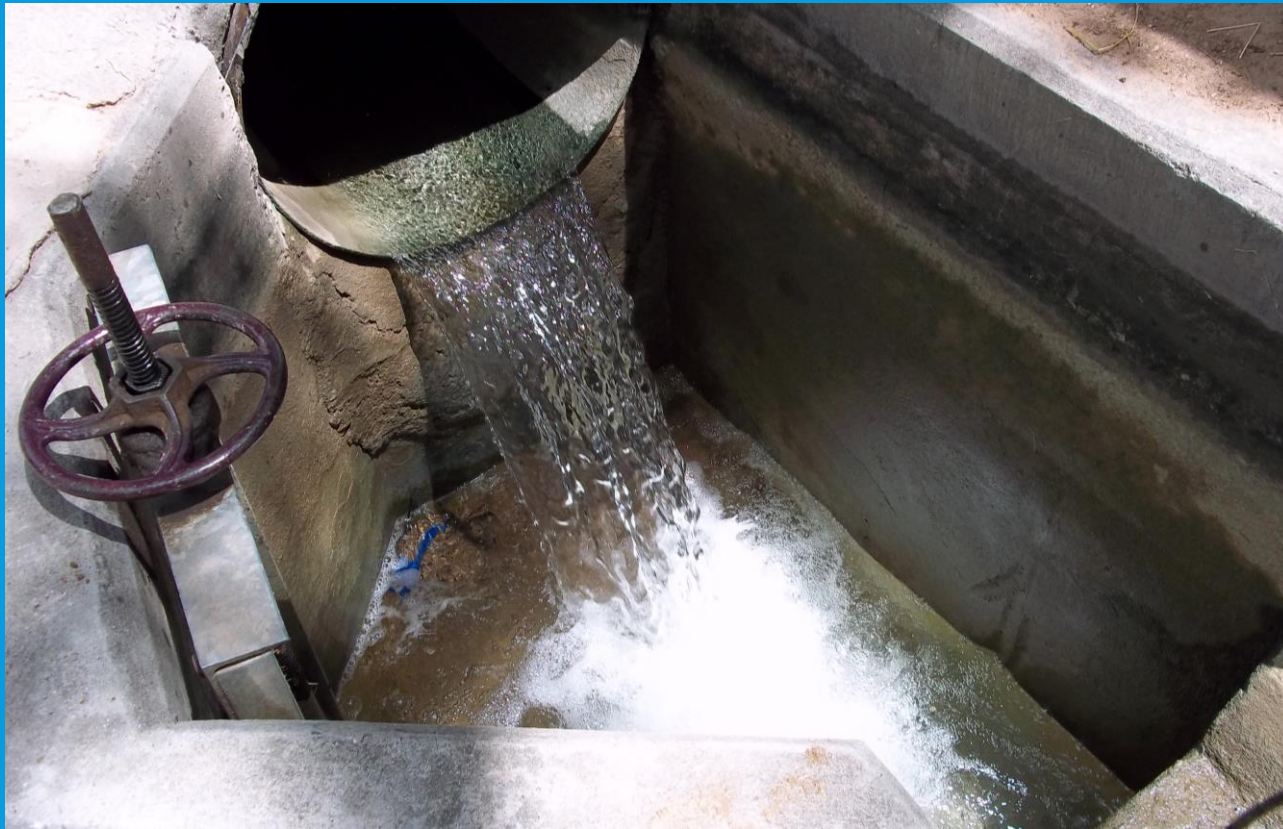
MAYORDOMO KEEPS THE DESAGUES CLEAN

This is a clean and functional desague. During irrigation season, the desagues are flushed several times a week. Our Mayordomo is diligent in keeping the desagues clean.

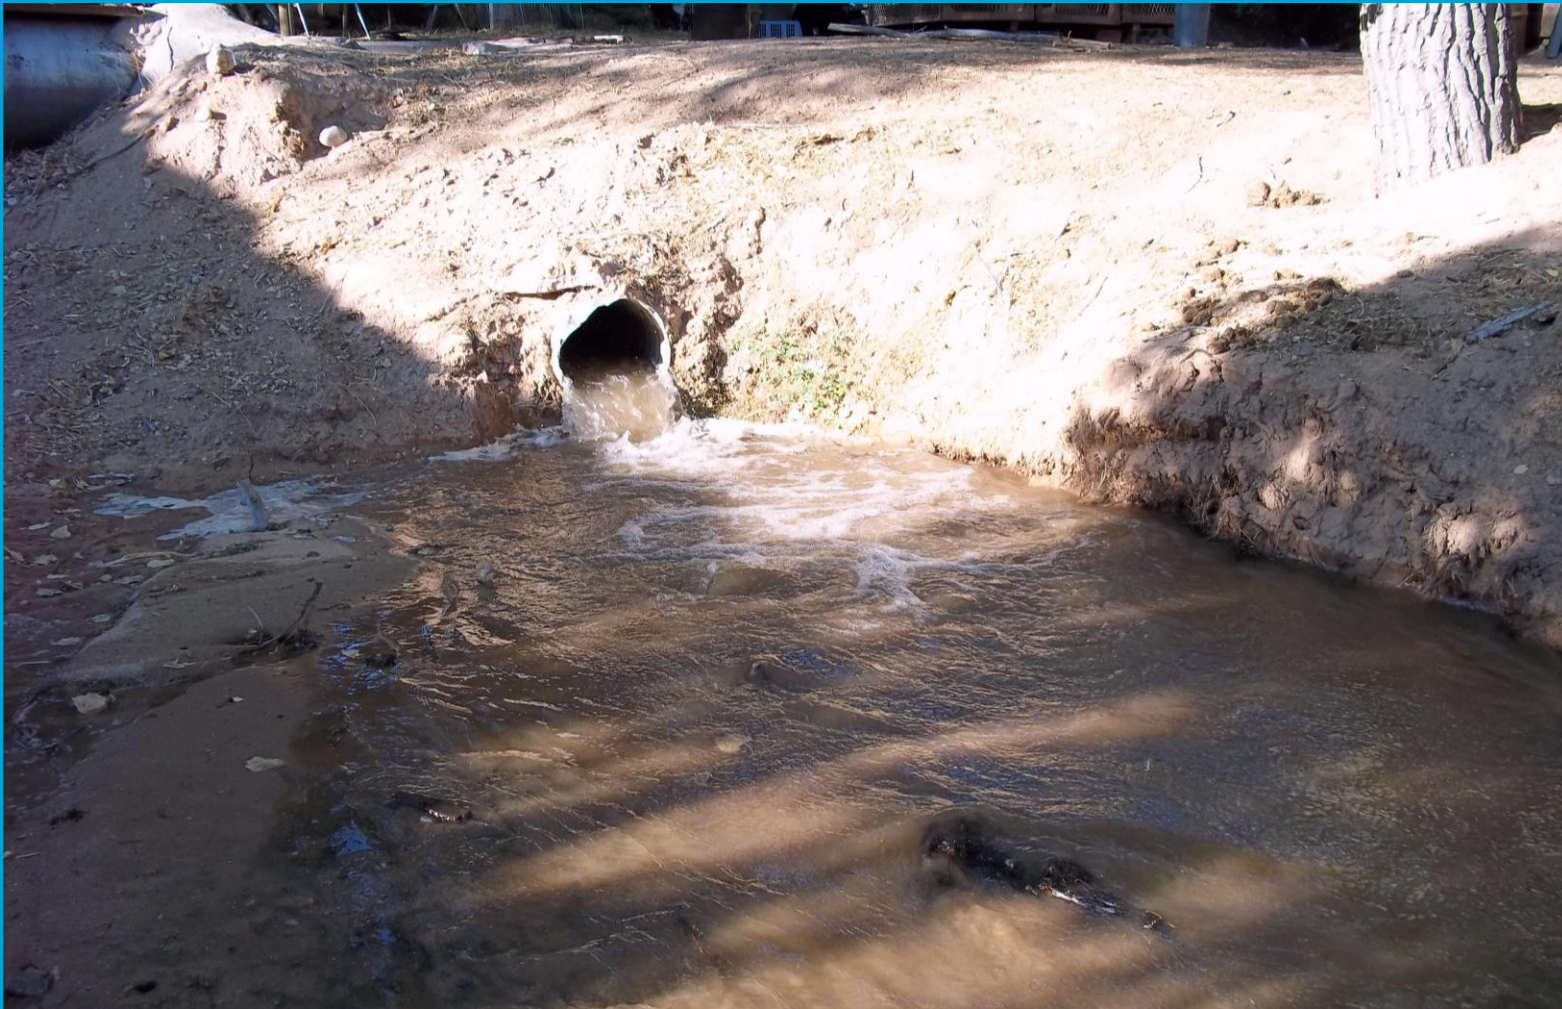
FLUSHING THE DESAGUE

This is the acequia's second desague. It is in a strategic location and it is very important to keep this desague open and functioning properly. The acequia is flushed into an arroyo which runs to the Santa Cruz River.

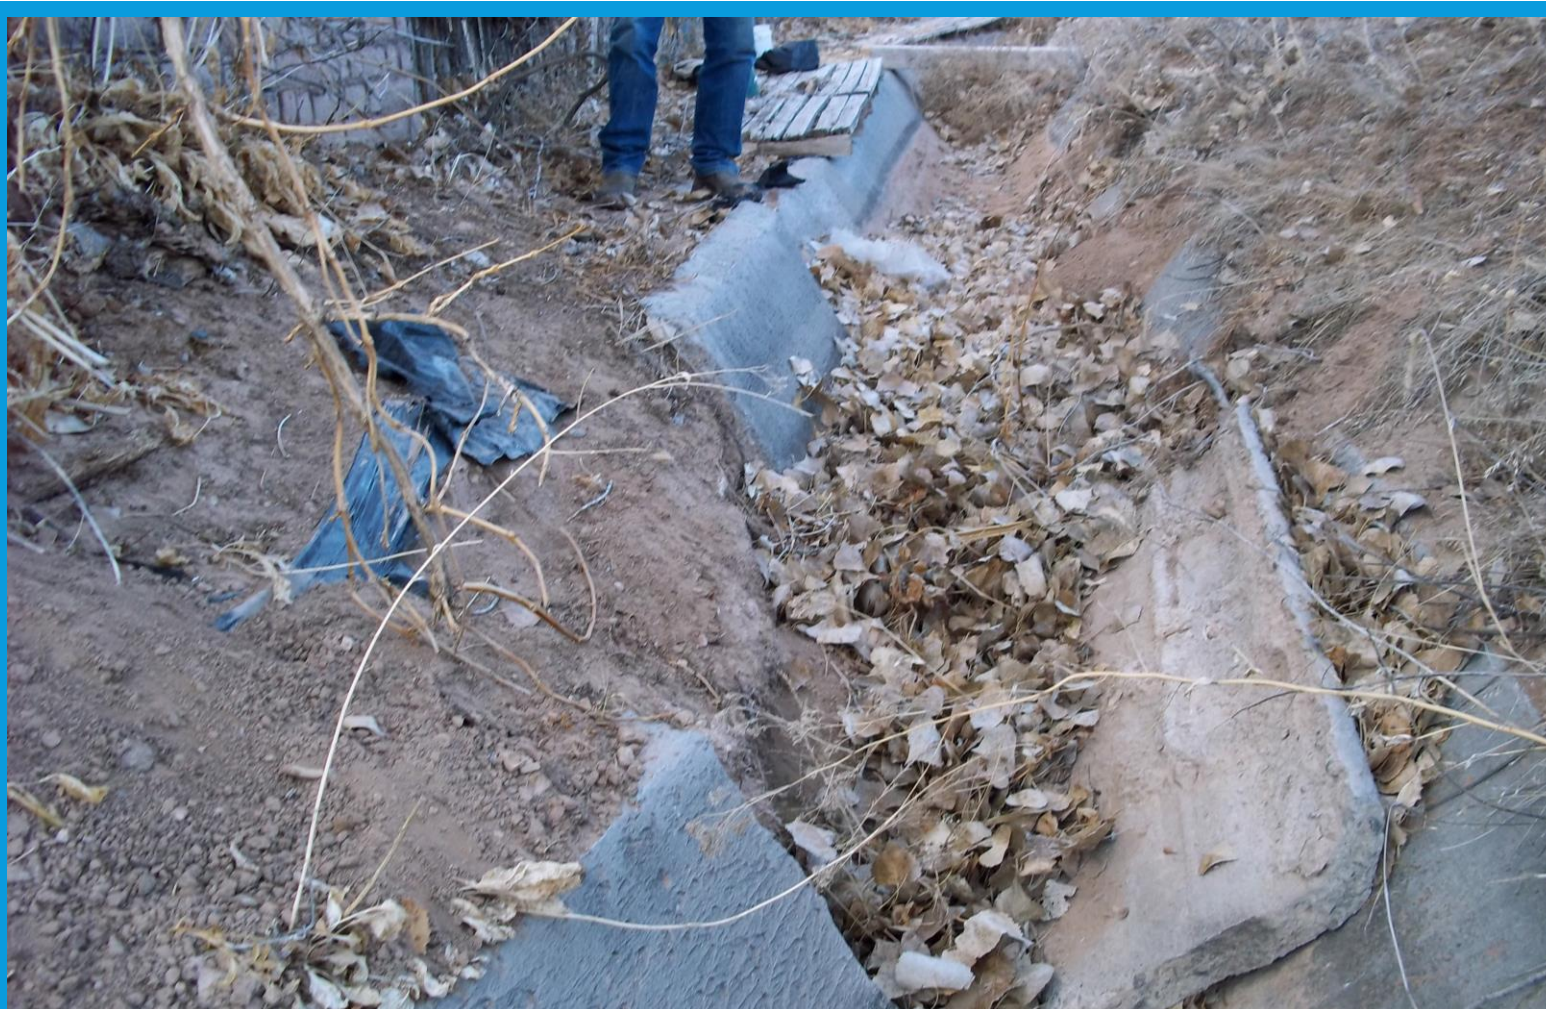
ACEQUIA IN NEED OF REPAIR

This is an area where the cement liner is broken in several places. There are other areas along the acequia where the cement is broken. There is a large cottonwood tree along the acequia which may have caused the liner to break.
