ACEQUIA DE LA PUEBLA

2013 ANNUAL MEETING

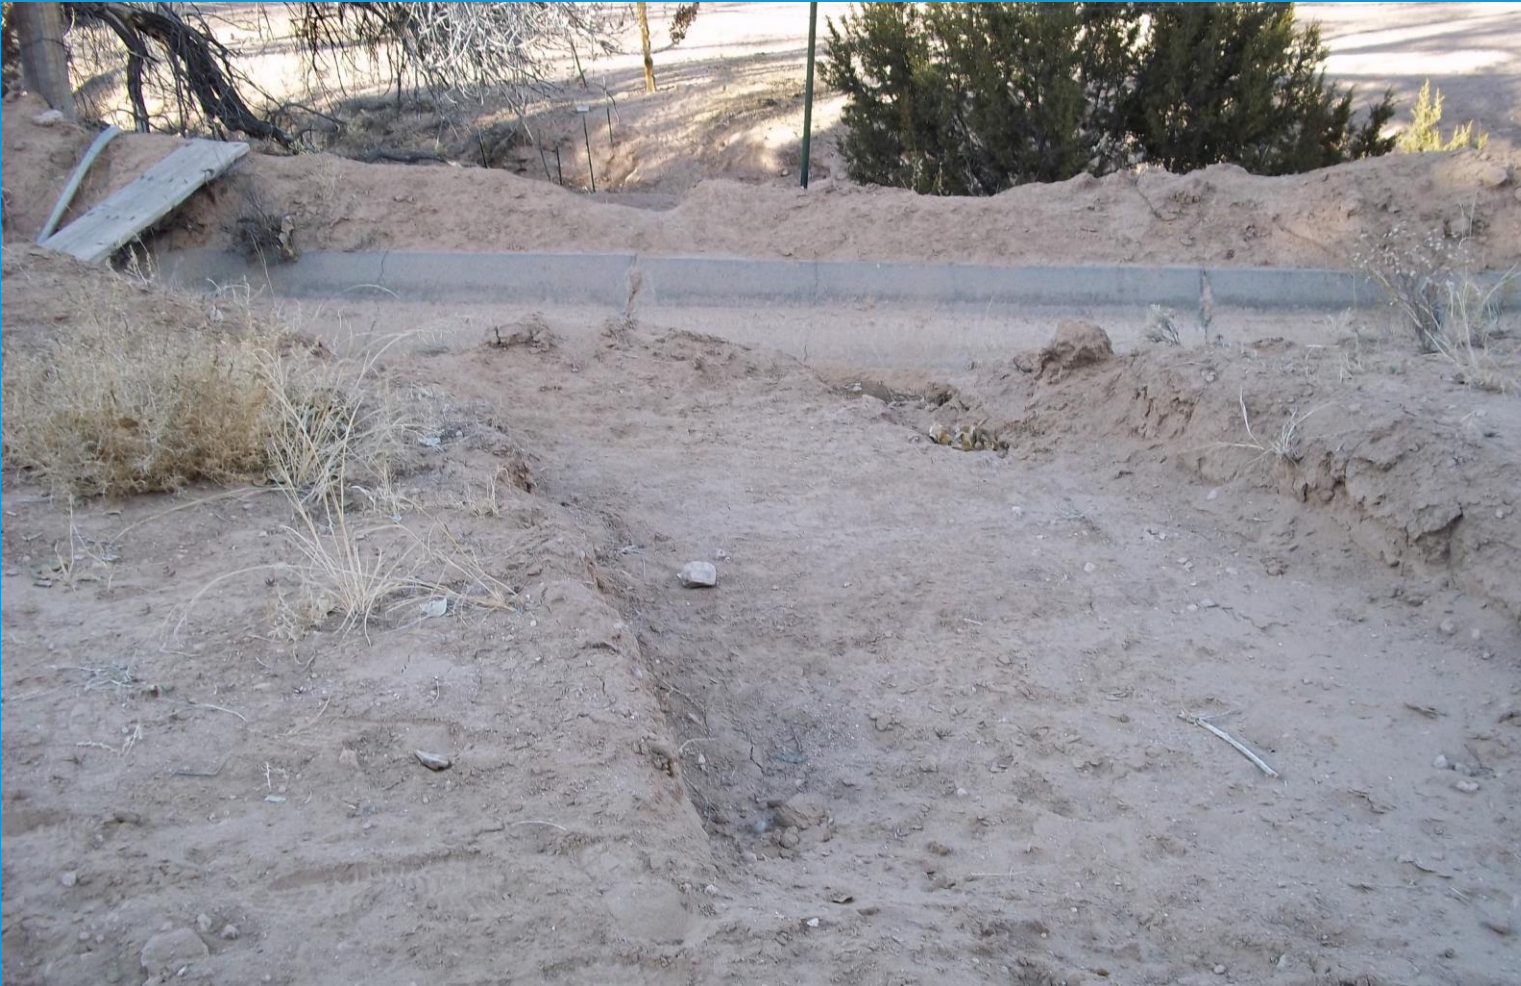
RUN-OFF CHANNELED INTO ACEQUIA

An individual has channeled run-off into the acequia. The Mayordomo is frequently monitoring the acequia for issues such as these. Some individuals are not parciantes, yet they interfere with the functioning of the acequia.

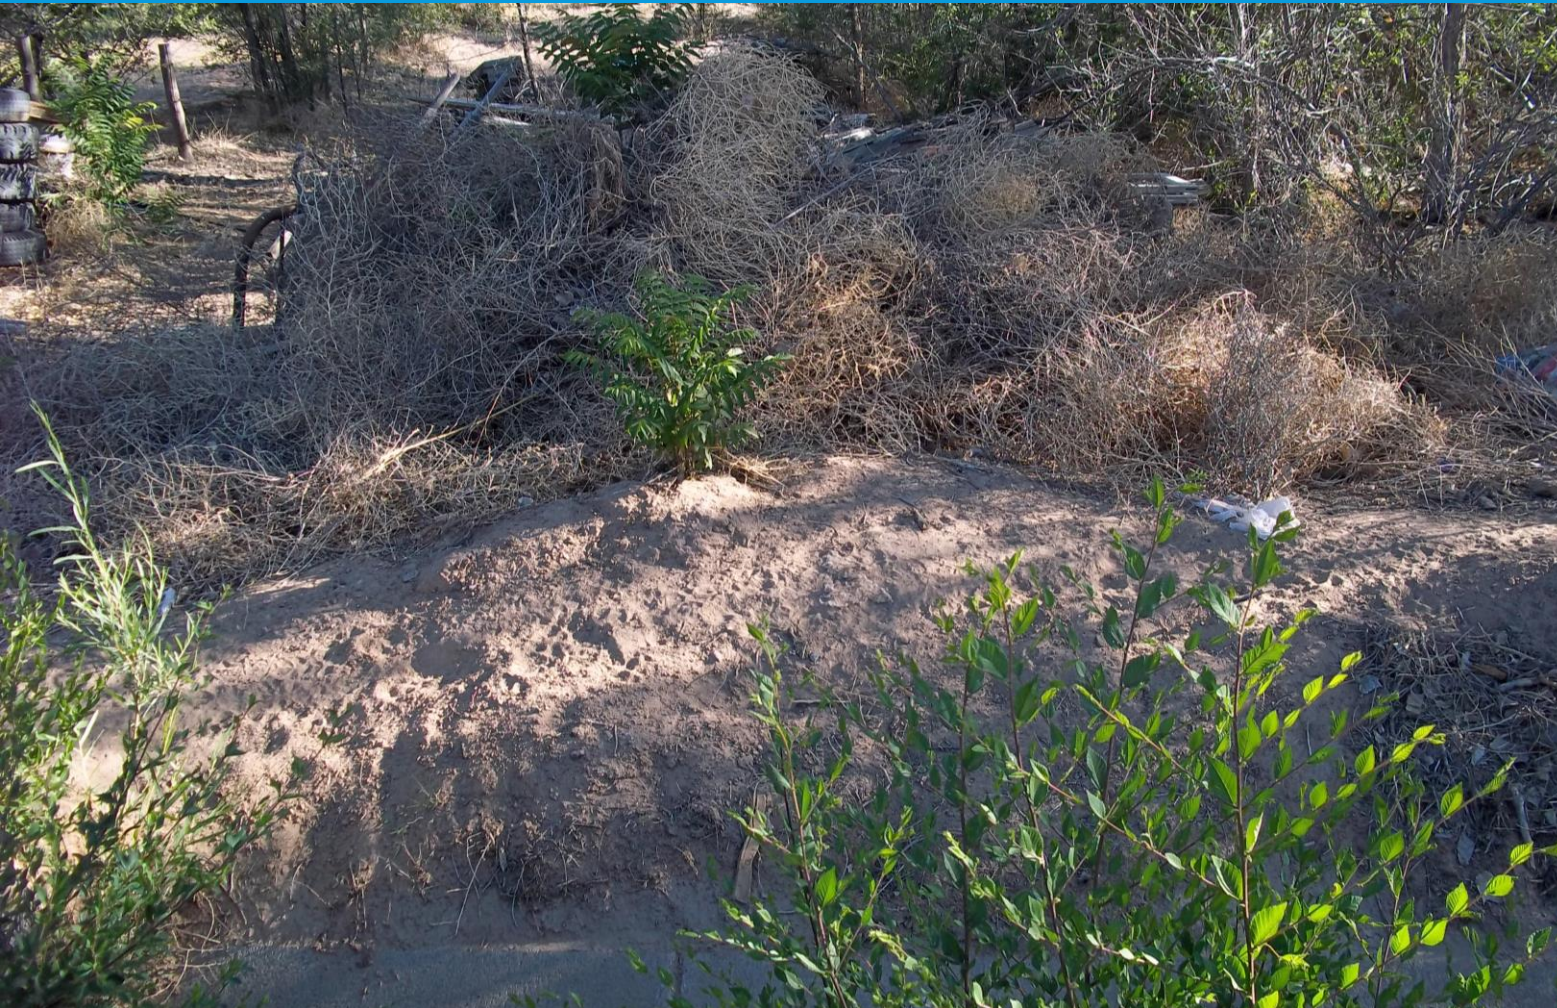
A TUMBLEWEED PILE ON ACEQUIA BANK

In the Spring, tumbleweeds are numerous. The tumbleweeds lead to many problems, such as blockages and overflows of the acequia. The by-laws state that all parciantes shall keep their acequia sections free of trash and other obstructions (Article 6, Section 1).

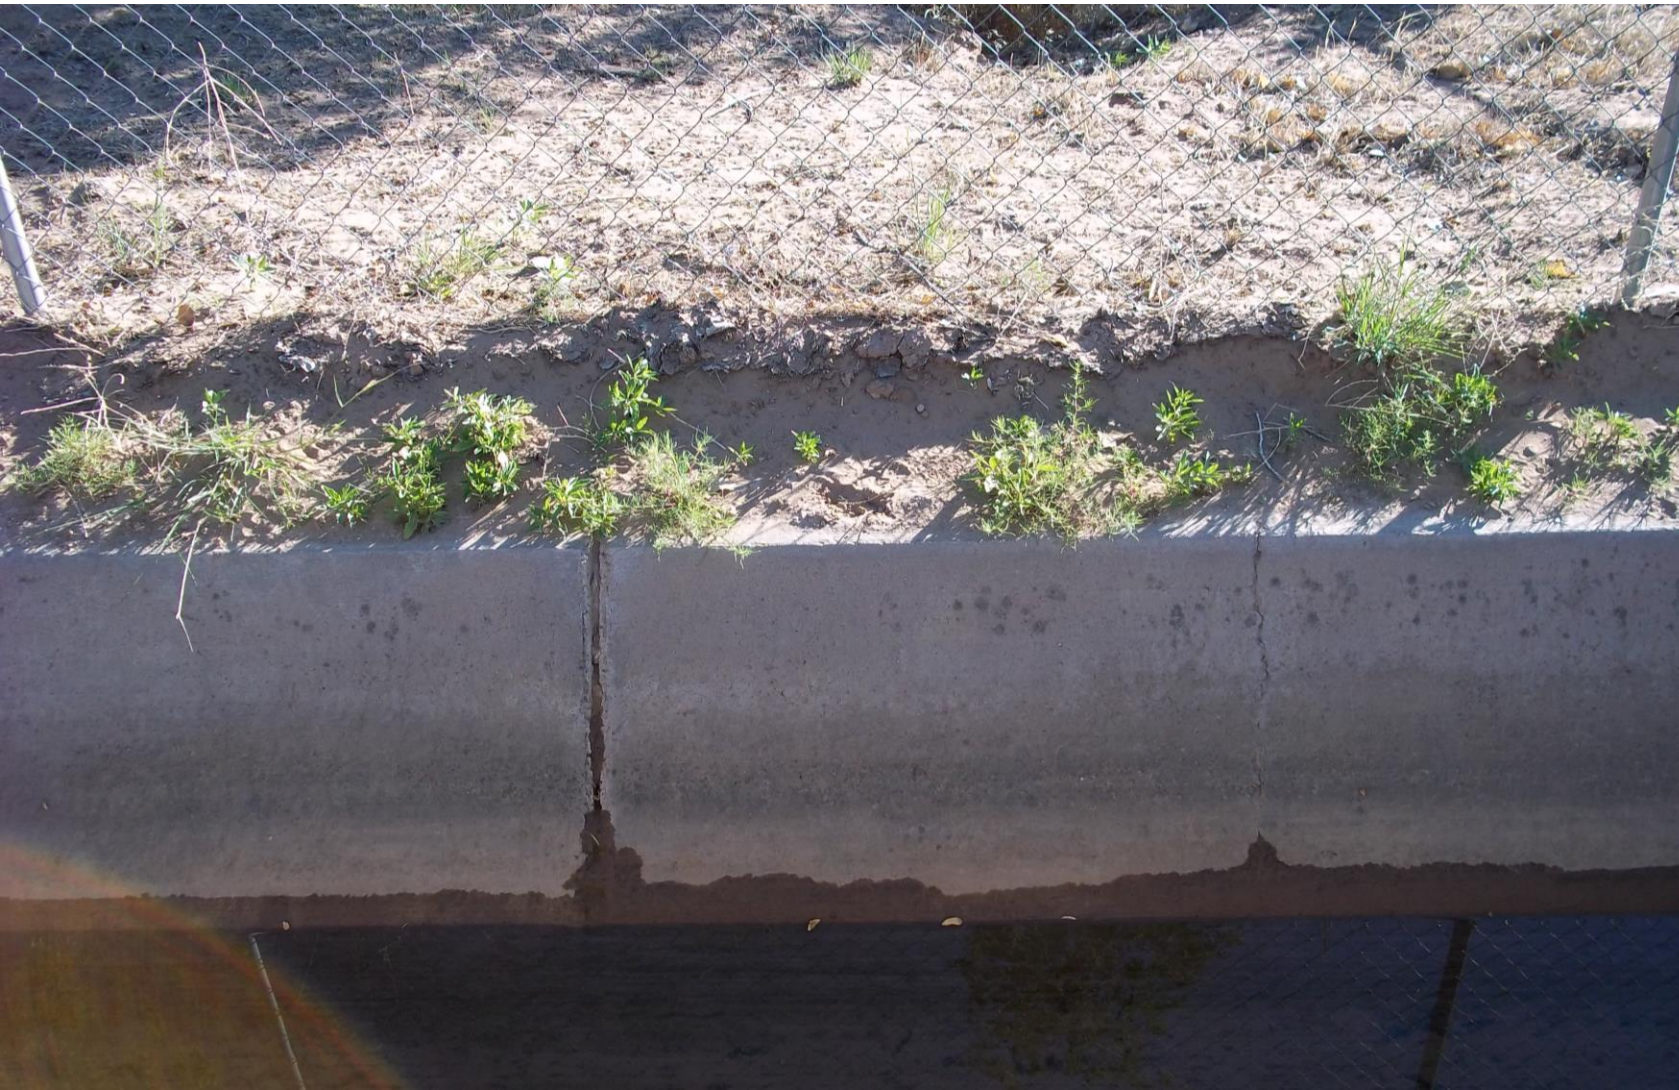
FENCE ON ACEQUIA BANK

This fence is too close to the acequia. The acequia's easement is described in Article 7, Section 1 of the by-laws. It states "The easement is as wide as necessary for maintenance, use and improvements".

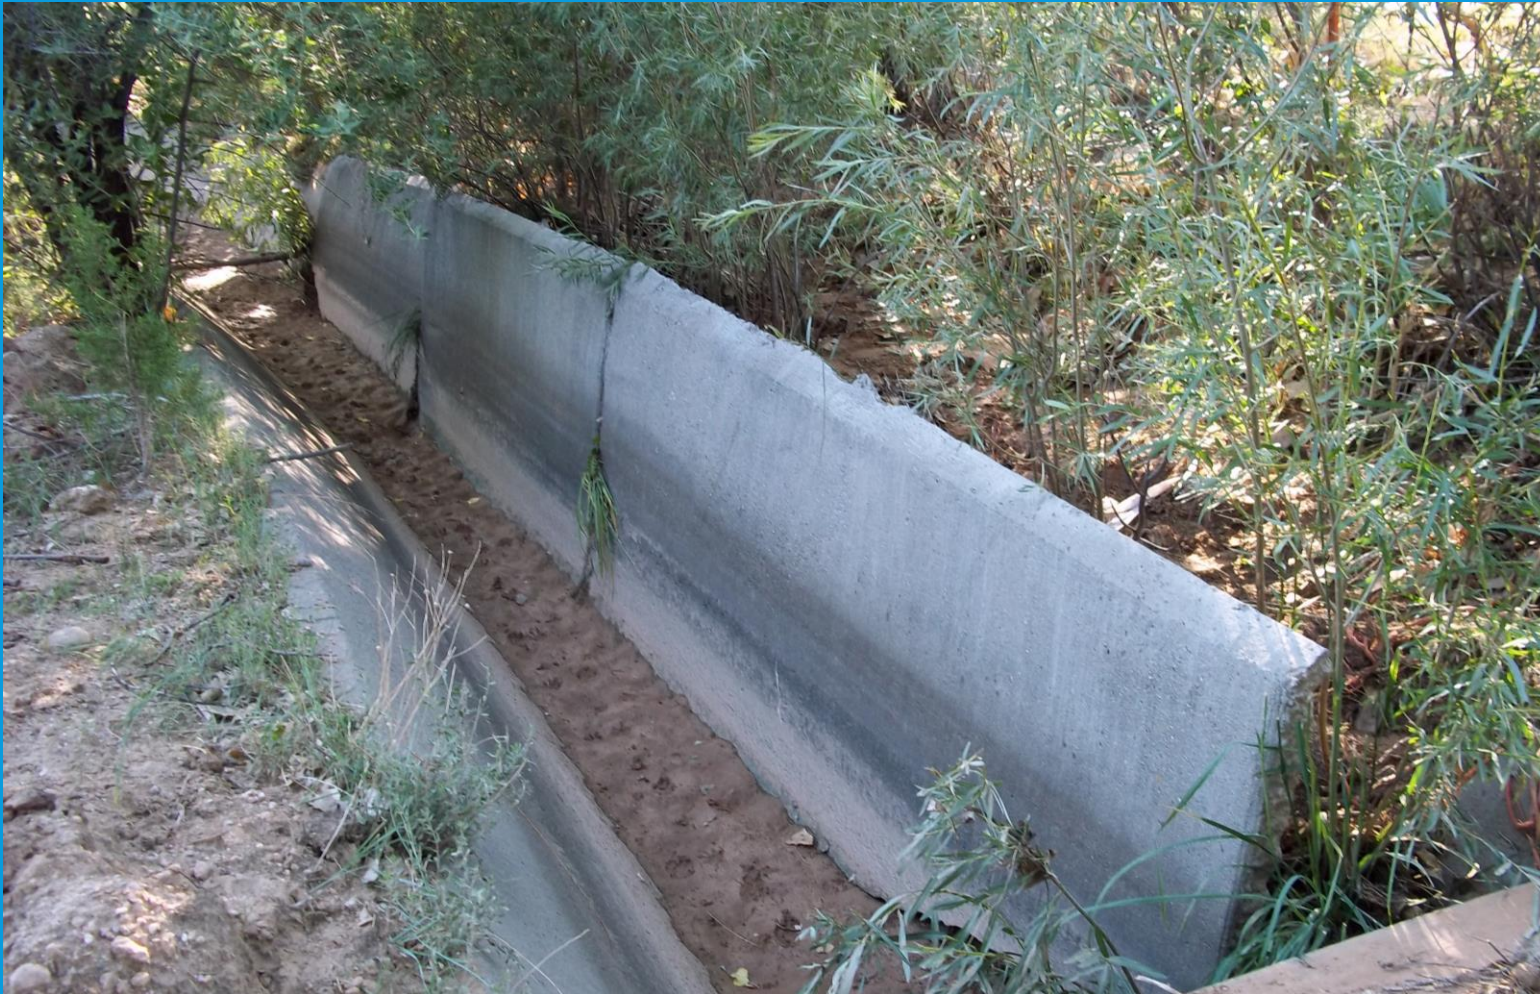
BROKEN ACEQUIA LINER

Several cement sections of the acequia have fallen forward. This summer one was removed because it had fallen into the acequia and was creating a blockage. The mayordomo was able to enlist the landowner and his neighbor, who are both parciantes, to help remove the cement section.

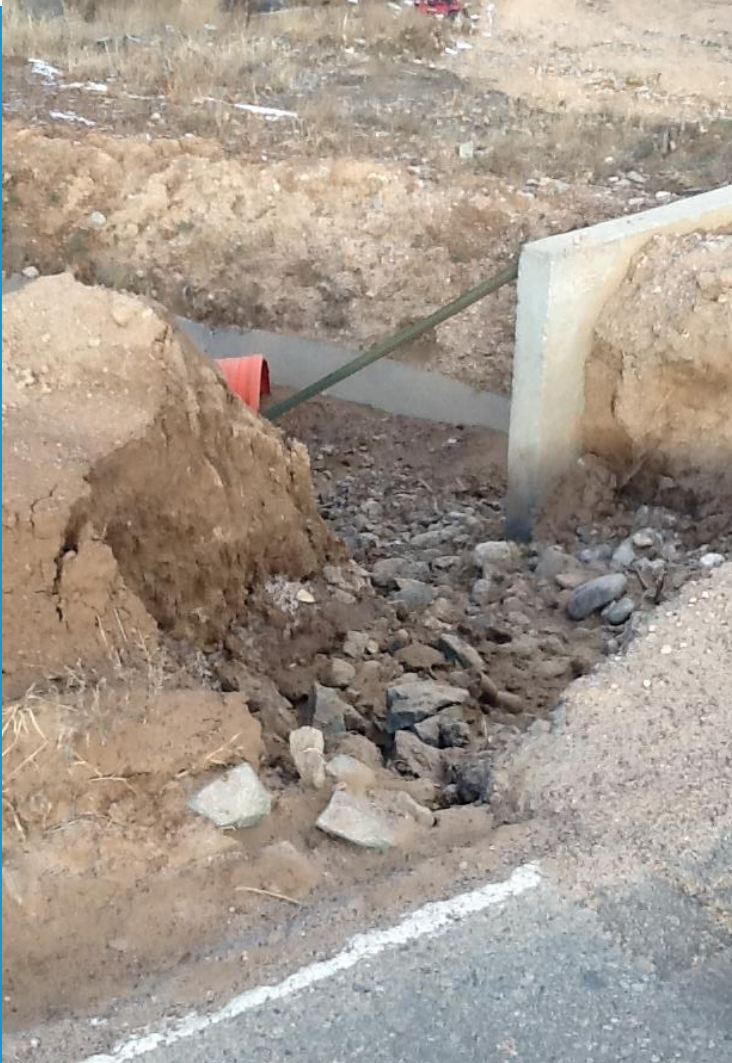
EROSION OF COUNTY ROAD 88

The run-off from County Road 88 is going into the acequia. This occurred after the September 2013 flooding. Art cleaned this area by hand. He has also contacted SFC for assistance with this issue.
